**CITY OF SAINT PAUL
HERITAGE PRESERVATION COMMISSION STAFF REPORT**

FILE NAME: 51 West Seventh Street - Church of the Assumption
DATE OF APPLICATION: February 26, 2013
APPLICANT: Melissa Ekman, Miller Dunwiddie Architecture
OWNER: Church of the Assumption
DATE OF REVIEW: March 28, 2013
HPC SITE/DISTRICT: Individual Historic Site
CATEGORY: Pivotal
CLASSIFICATION: Demolition Permit
STAFF INVESTIGATION AND REPORT: Christine Boulware
DATE: March 20, 2013

EXTERIOR ASSESSMENT AND DEMOLITION RECOMMENDATIONS
FOR THE
CHIMNEY AT THE CHURCH OF THE ASSUMPTION

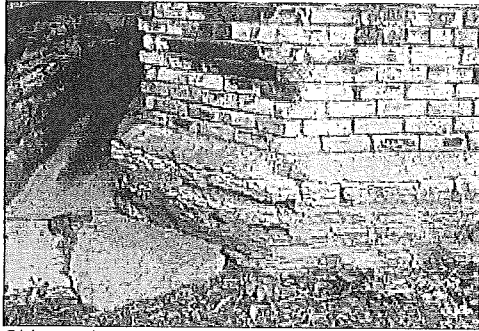
Chimney base.

The shaft of the chimney appears to be Chaska brick, a very soft and porous brick, sitting on a Platteville limestone foundation. The foundation stone and joints are severely deteriorated and have been parged-over with multiple layers of mortar. There is also significant biological growth at the masonry of the chimney and the church. Due to this area being located on the north side of the church, and the chimney mass blocking airflow, the biological growth is most likely the result of very poor air circulation in this area.

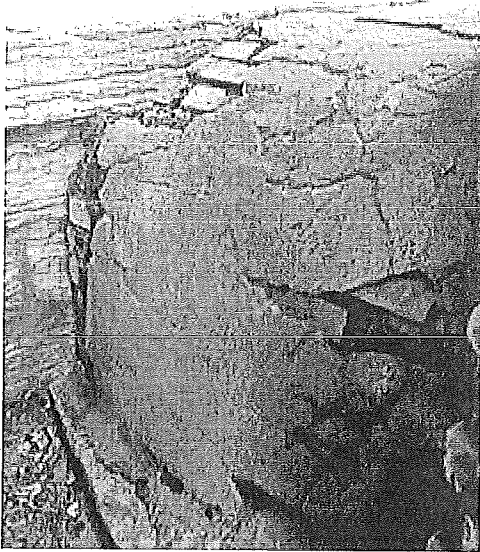
Parge coating at masonry and biological growth.

The first 15 courses of brick above the foundation have severely deteriorated mortar joints and spalled brick surfaces. The remaining bricks up to the chimney cap are severely discolored by atmospheric pollutants. The top five to six feet of the chimney also have severely deteriorated joints and spalled brick faces.

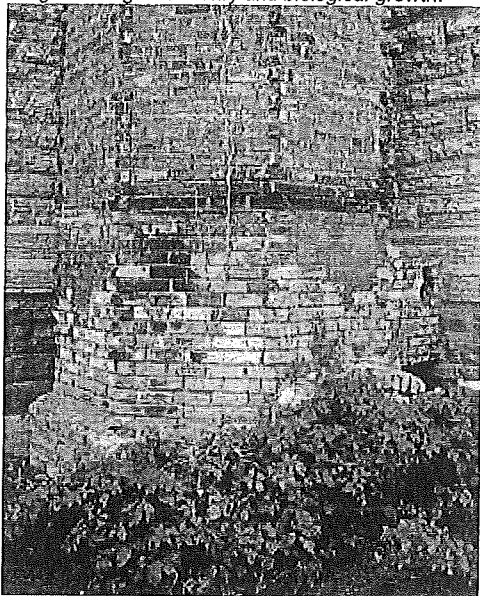
Efflorescence, spalling brick, and mortar joint deterioration at the bottom 15 courses above the stone foundation.

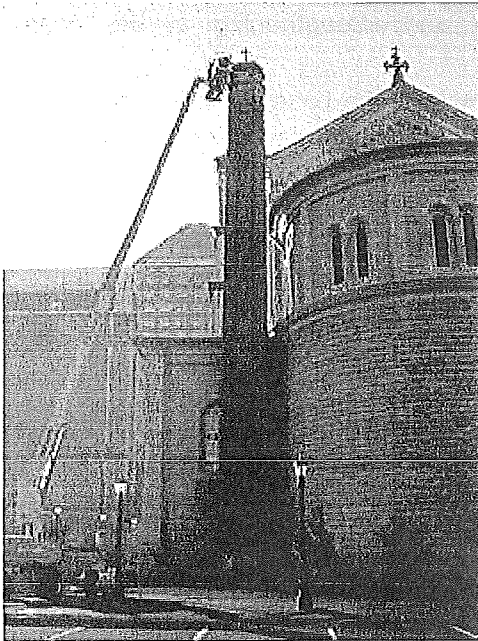
A visual inspection of the chimney from grade also shows that the chimney is leaning towards the northeast corner of the church. McGough Construction Company was engaged to verify the chimney dimensions and the extent that the chimney is leaning (see Appendix A for diagram). Through the use of a lift, the team was also able to visualize the interior of the chimney with a camera.

Looking south – the chimney leans south and west towards the church.

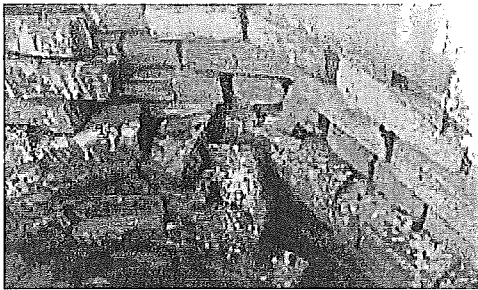
The interior top eight feet of masonry was seen to be in extremely poor condition with the majority of the inner wythe of brick missing and with very sandy mortar joints. The next approximately 15 feet were also in very poor condition; however, with less brick damage. The church staff has reported that removal of buckets-full of masonry rubble and debris is regularly required from within the shaft for the boiler to function.

Inside chimney brick condition at the top of the stack.
